Evaluation Of Thermal Sprayed Metallic Coatings For Use On The Structures At Launch Complex 39

MTB-1058-89

SUBJECT: EVALUATION OF THERMAL SPRAYED METALLIC COATINGS FOR USE
ON THE STRUCTURES AT LAUNCH COMPLEX 39

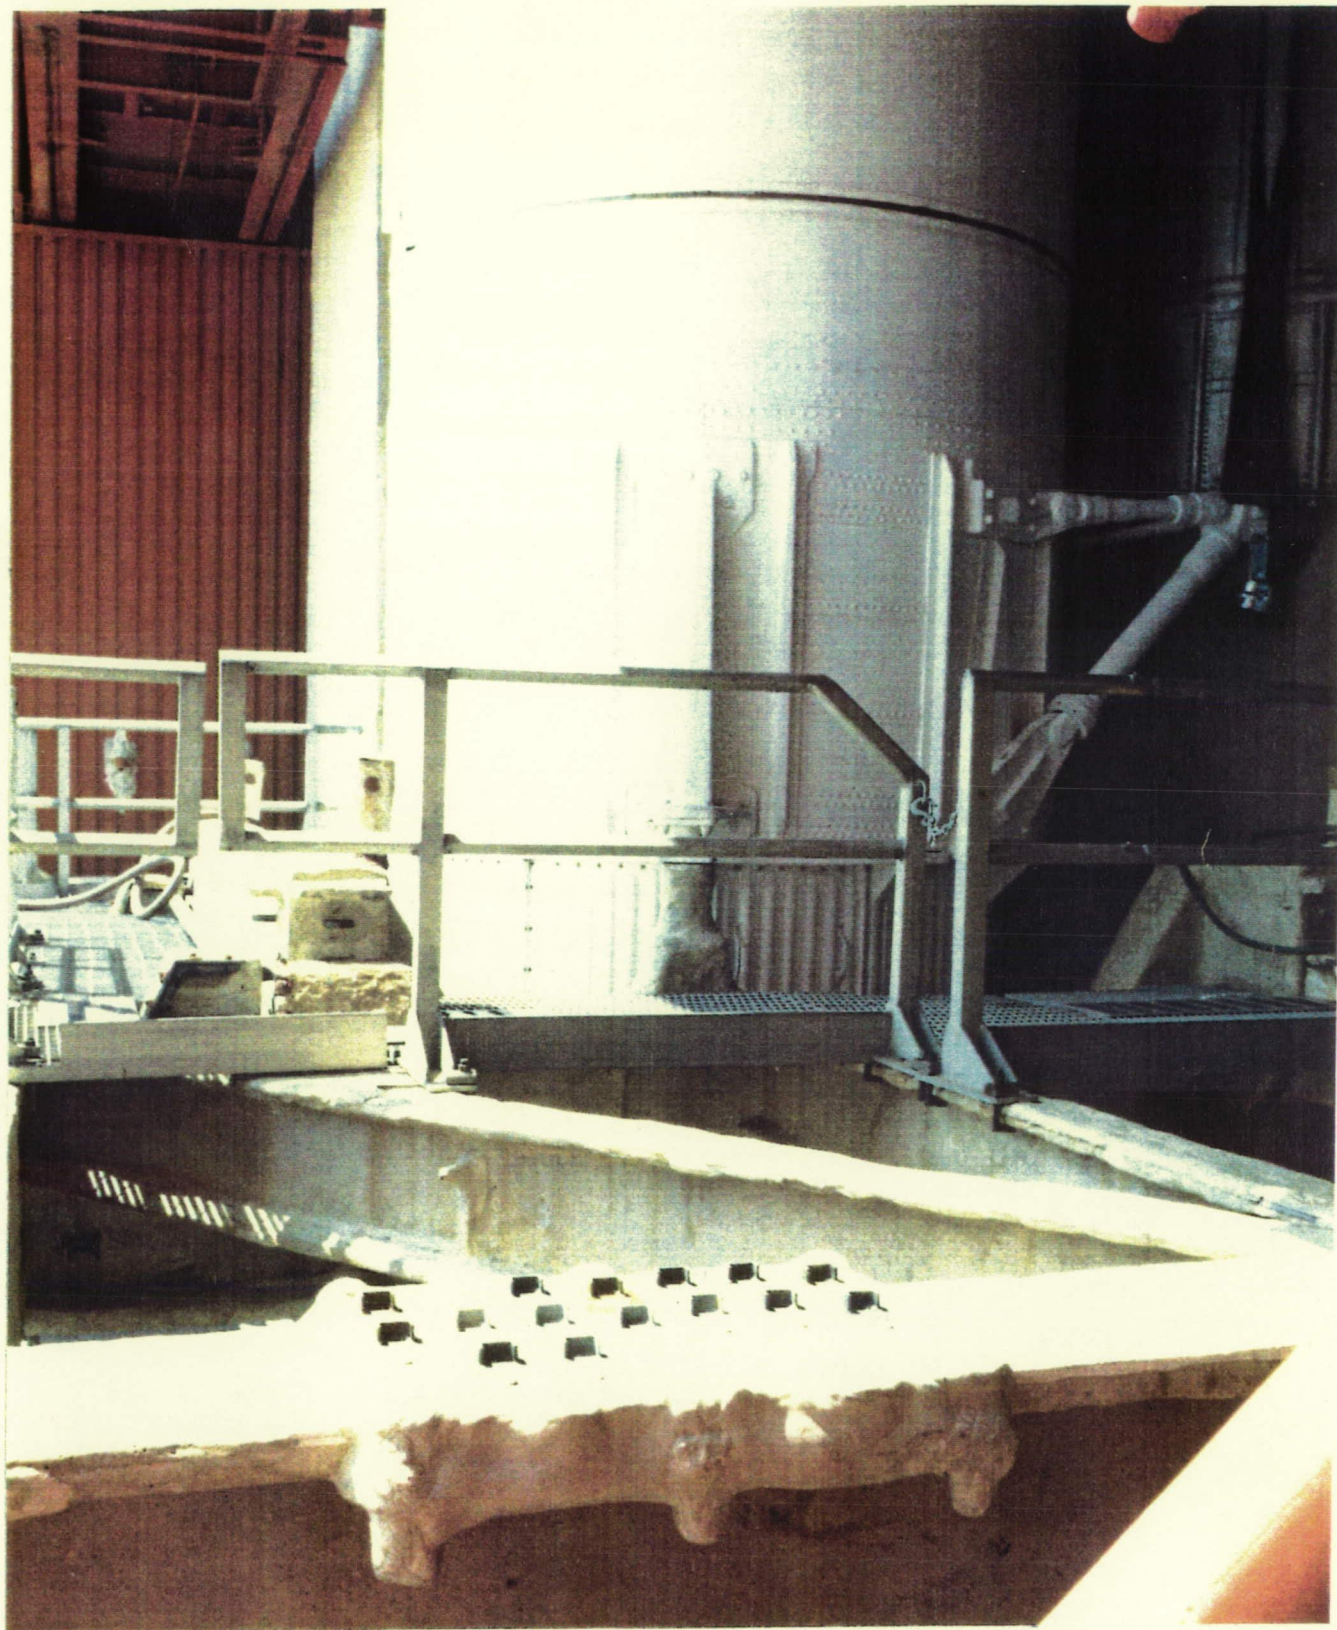
FIGURE 1

THE MOUNT PLATE WITH TSC COMPOSITE TEST PANELS IS SHOWN MOUNTED ON THE TITAN TRANSPORTER PRIOR TO THE TITAN LAUNCH ON SEPTEMBER 5, 1989.

- 2.1 Eleven new thermal spray coating (TSC) composite test panels, a strain isolation barrier, and 6 reference panels were secured to a mount plate which was attached to the Titan transporter at LC-40, at the same location described in MTB-781-88.
- 2.2 The mount plate was secured to the transporter several weeks before the Titan III launch on September 4, 1989, and returned to the MTB on September 7, 1989 (see Figures 1 and 2).
- 2.3 A group of TSC test panels were set out at the beach corrosion test site on April 15, 1987. Periodically the panels were rinsed with a slurry of Al_2O_3 powder and HCl to simulate the effects of the SRB exhaust residue.

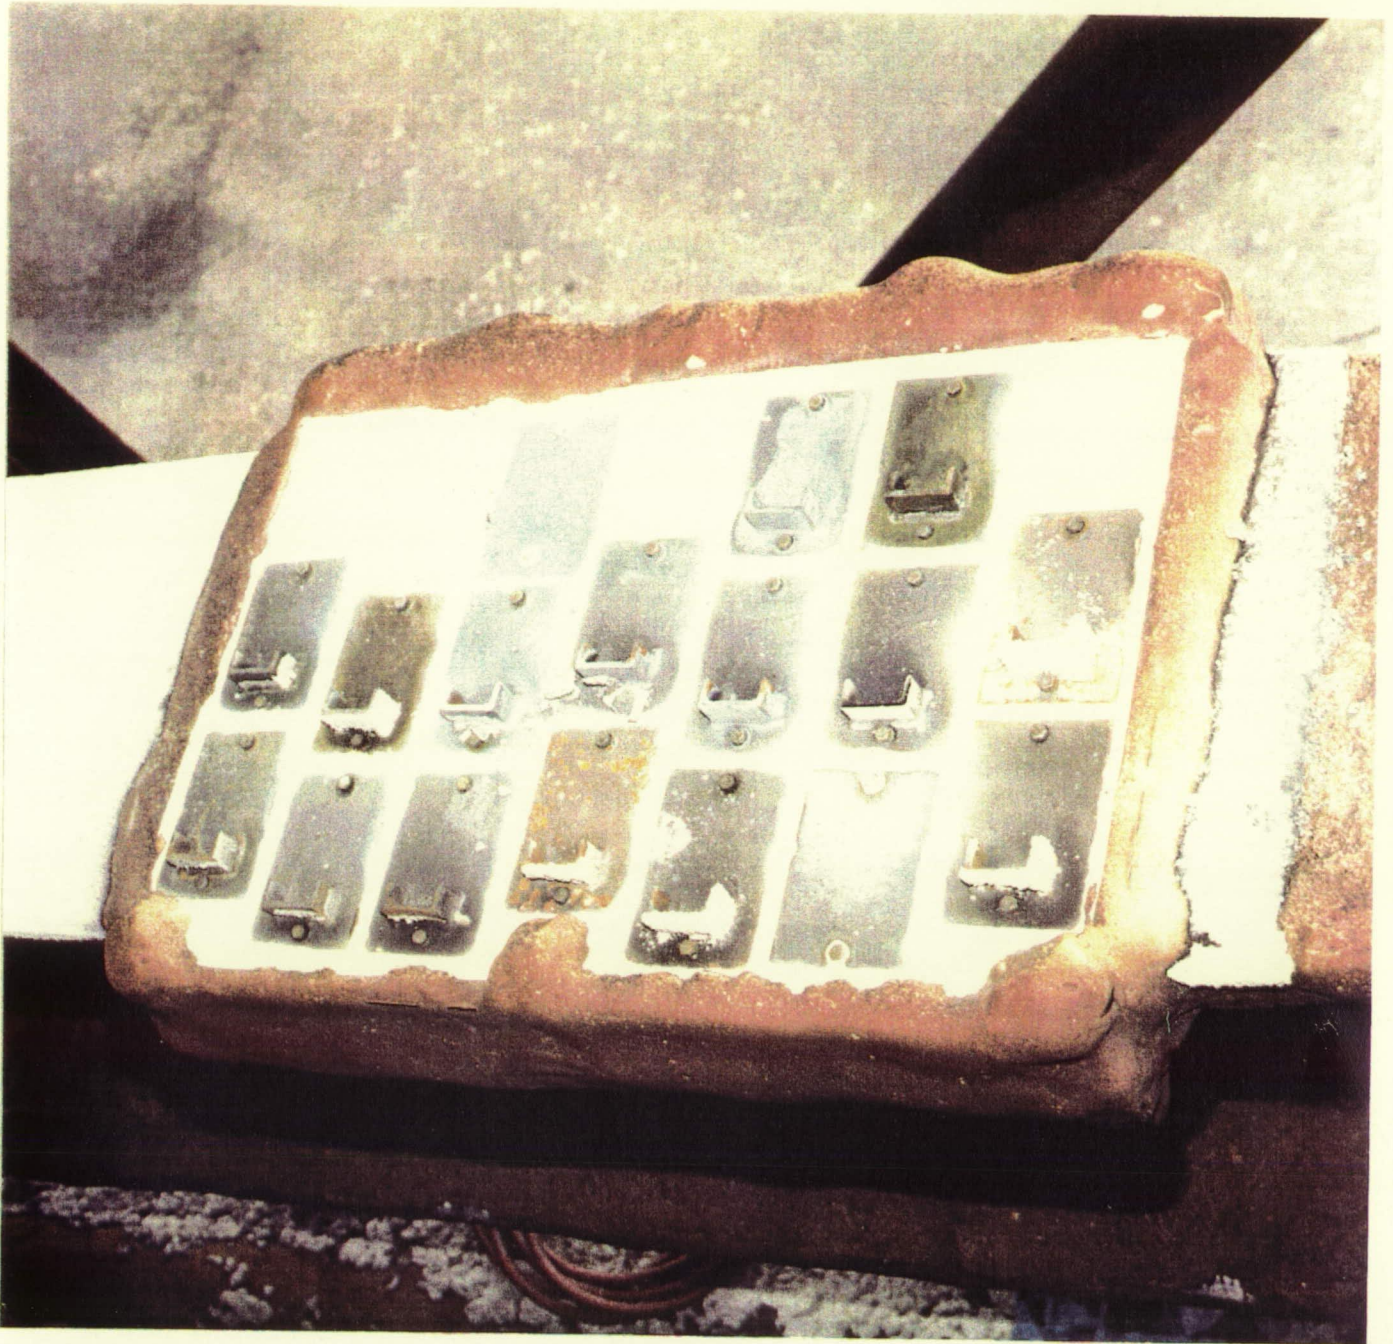
FIGURE 2

THE MOUNT PLATE WITH TSC COMPOSITE TEST PANELS IS SHOWN MOUNTED ON THE TITAN TRANSPORTER AFTER THE TITAN LAUNCH ON SEPTEMBER 5, 1989.

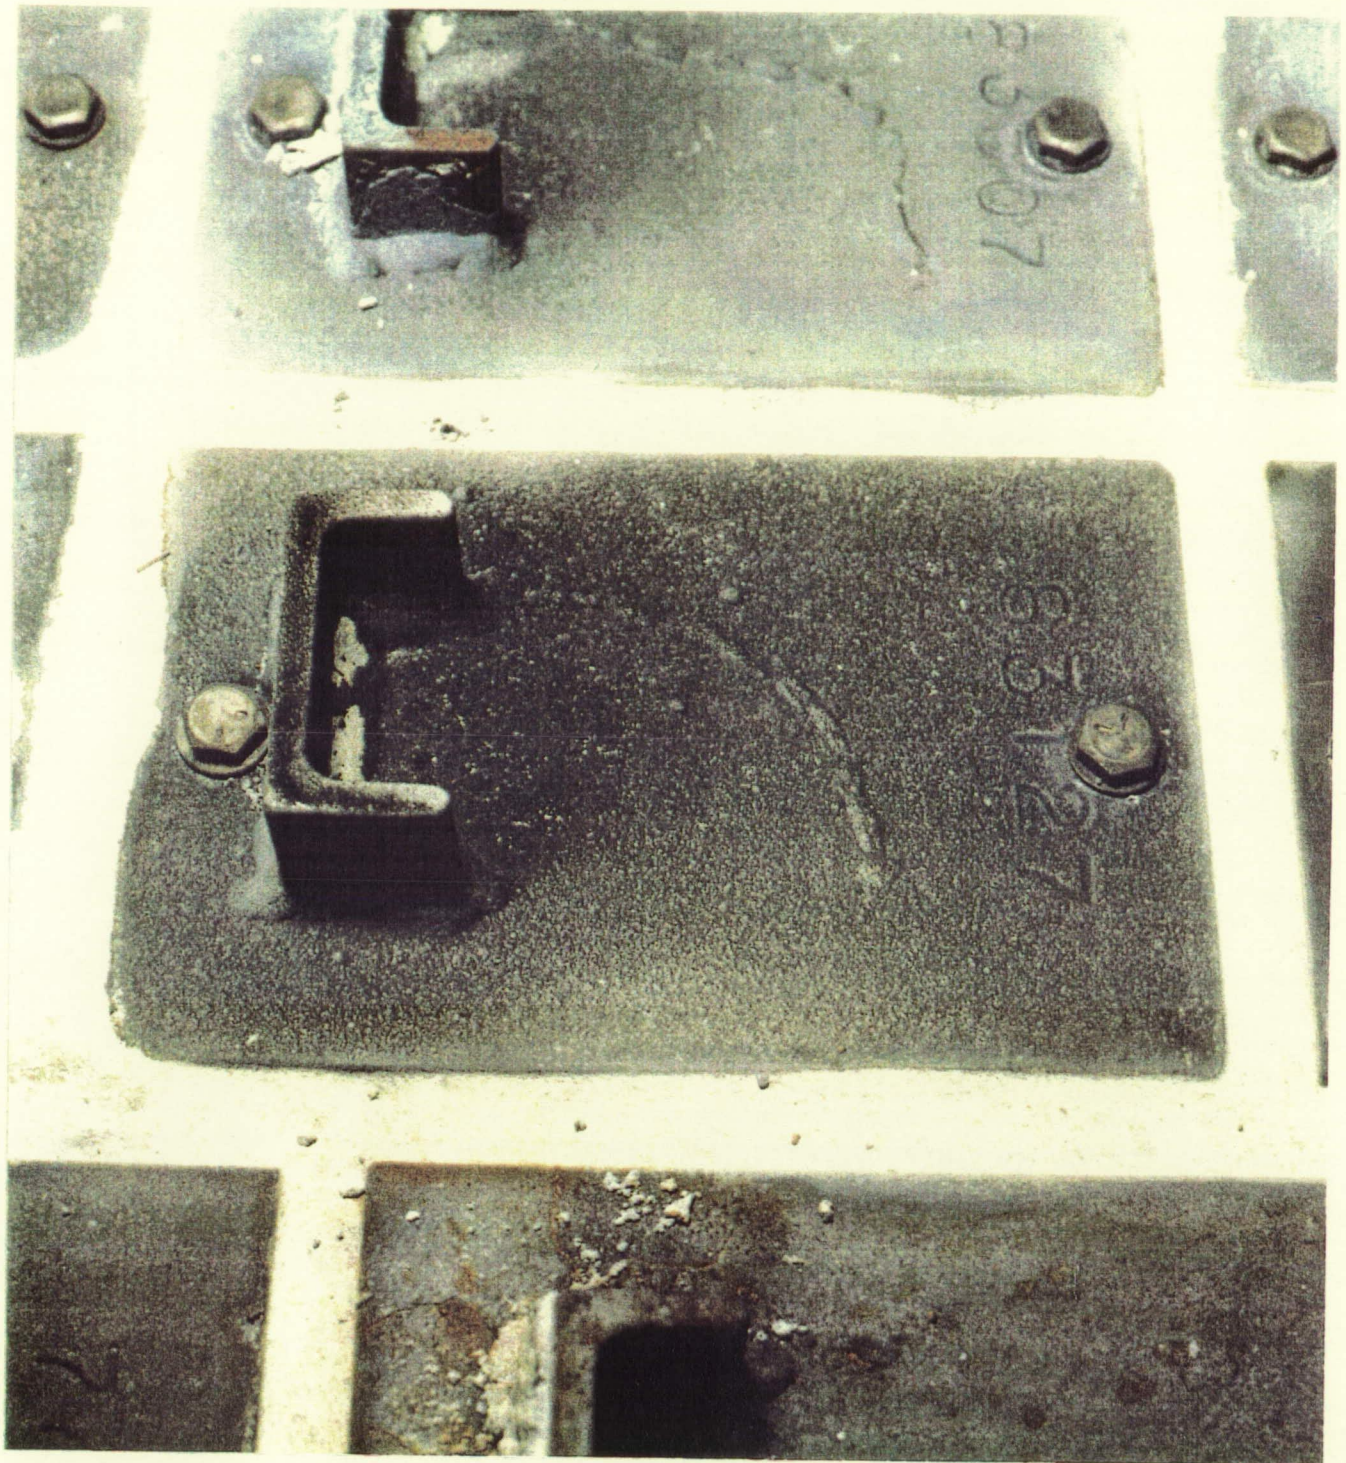
FIGURE 3

THE ALUMINUM TSC TEST PANEL, S/N 83127, WAS THE ONLY TSC PANEL WHICH DID NOT APPEAR TO SUSTAIN ANY DAMAGE FROM THE TITAN LAUNCH ENVIRONMENT.

3.3 Of the eleven new TSC panels only S/N 83127 showed no noticeable damage (see Figure 3). It was coated with aluminum. The results of all the panels are presented in Table II.

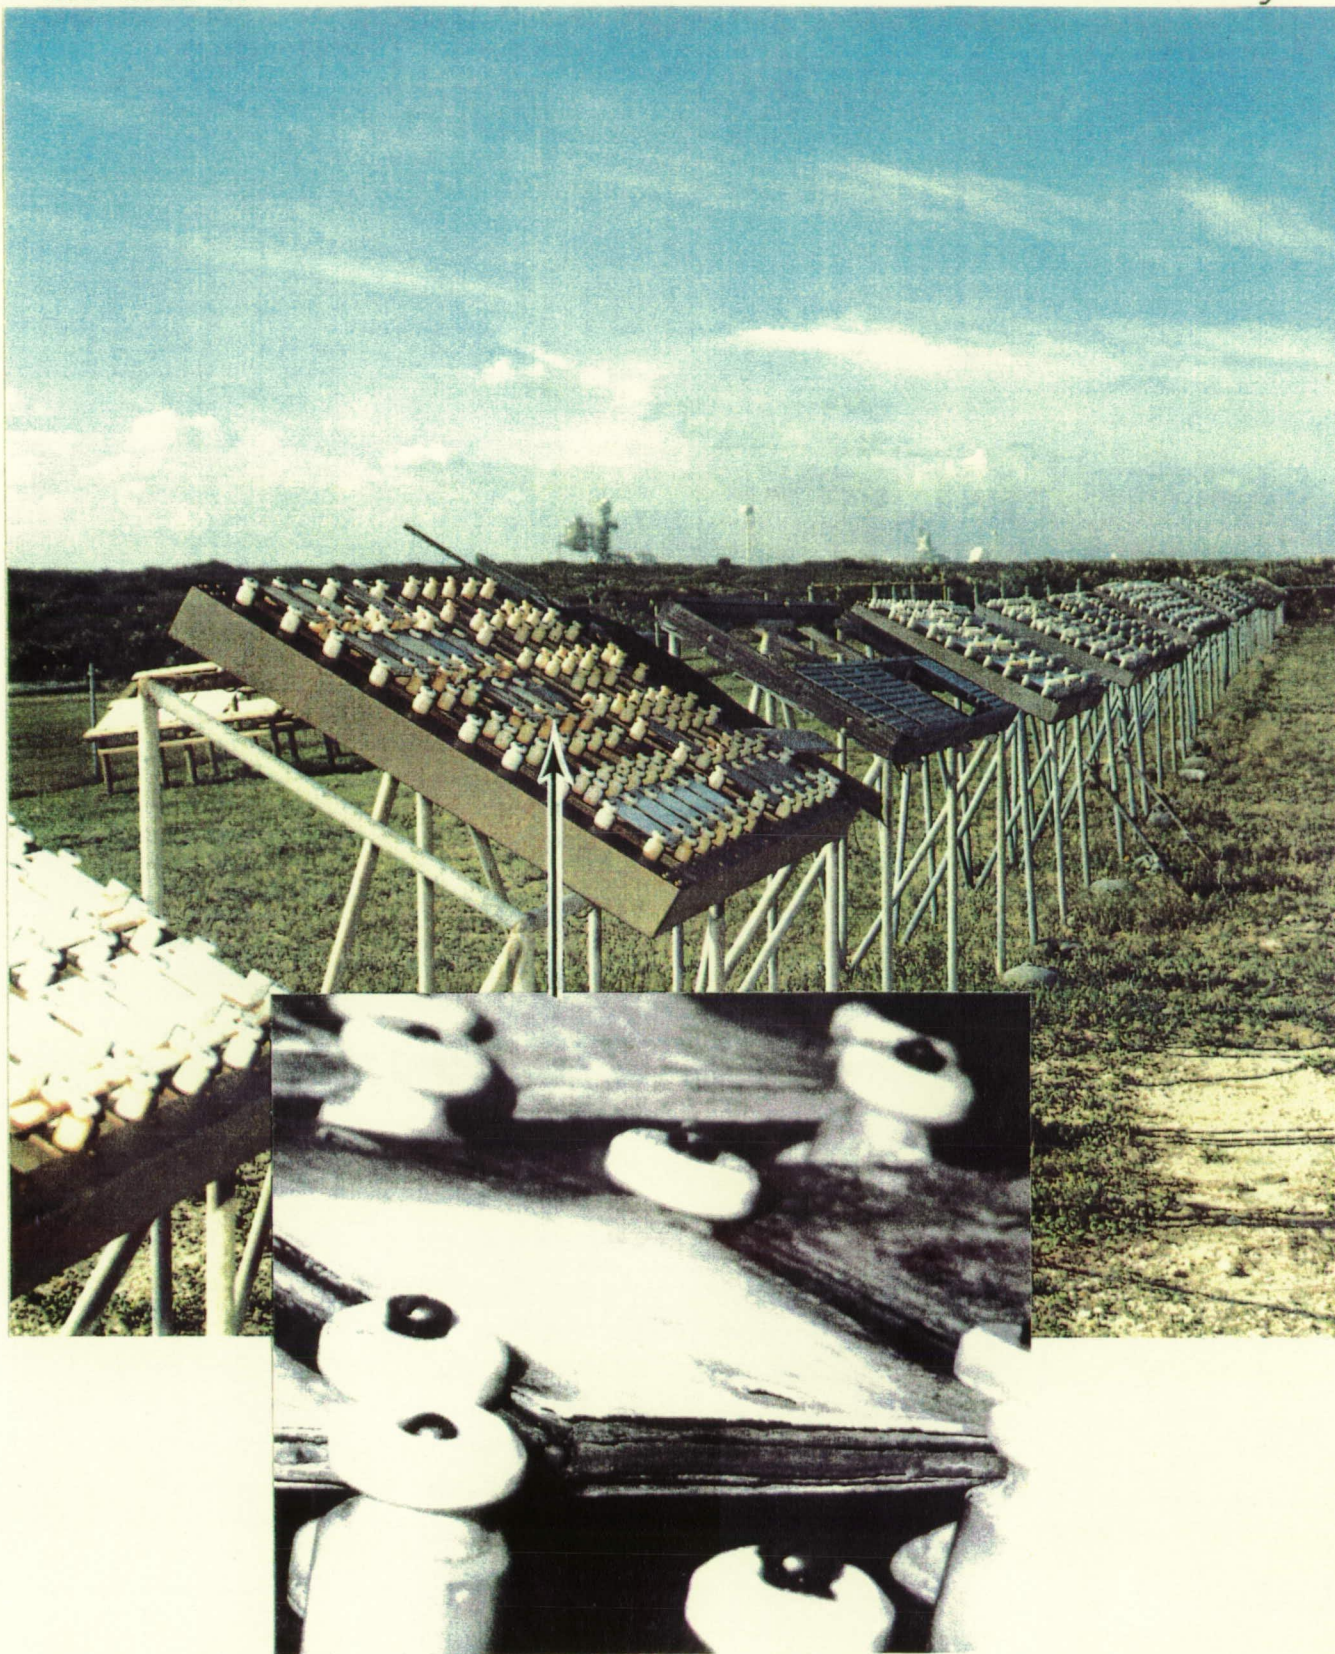
FIGURE 4

TSC TEST PANEL S/N 12342 WHICH WAS EXPOSED TO THE $\text{Al}_2\text{O}_3\text{-HCl}$ SLURRY AT THE BEACH CORROSION TEST SITE IS SHOWN AFTER 2-1/2 YEARS OF BEACH EXPOSURE. THE TSC WAS A Ni-Cr-W-Mo ALLOY.

- 4.2 Most of the TSC alloys applied by either plasma or hypersonic flame spray processes are more noble than the low alloy steels. In the case of these exotic, noble alloys, the carbon steel structure becomes the sacrificed cathode which corrodes. This undesirable phenomena was illustrated in the beach exposure tests.
- 4.3 The testing in the launch environment has illustrated the problems of porosity and exfoliation due to thermal shock. The use of the exotic TSC's to protect launch structure appears impractical.

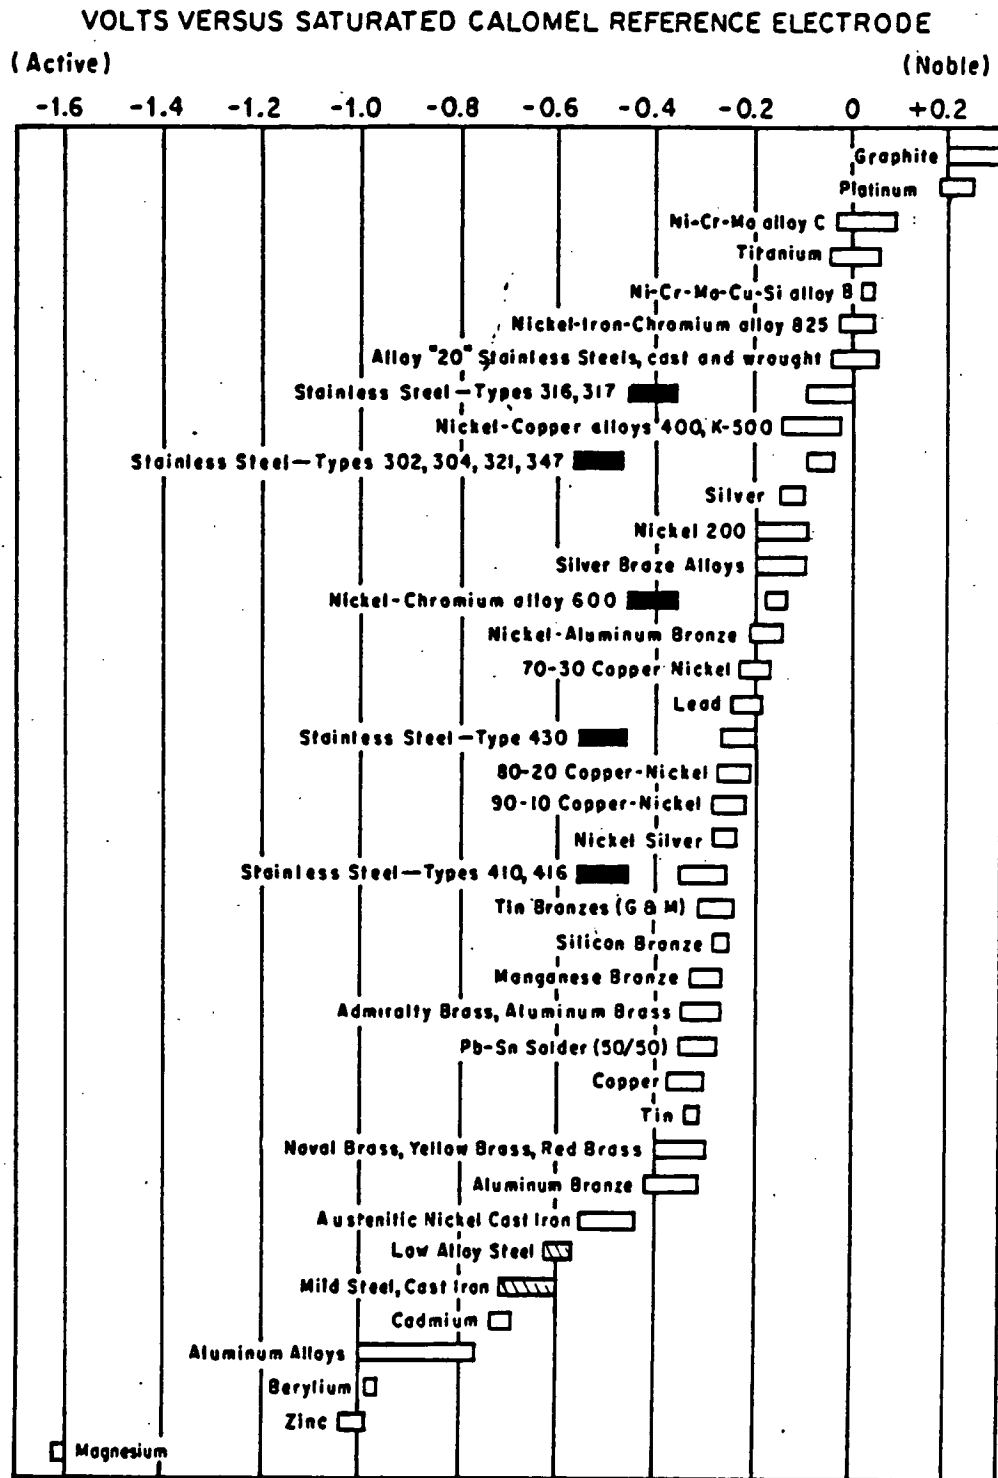
FIGURE 5

Note—Dark boxes indicate active behavior of active-passive alloys.

**GALVANIC SERIES OF VARIOUS METALS IN FLOWING SEAWATER
(REFERENCE ASTM G 82-83).**

4.1 Inorganic zinc paint is the standard protective coating for steel structures at Kennedy Space Center (KSC). In some applications inorganic zinc is utilized with epoxy and urethane based top coats. The zinc paint provides cathodic protection for the steel. As shown in the galvanic series (see Figure 5) zinc is more active than mild steel and low alloy steel; therefore, as a coating it corrodes sacrificially and provides a protective oxide barrier over the steel structure.
